## **STRUCTURAL INTEGRITY RESERVE STUDY**

**Bouchelle Island XXII  
Condominium Association, Inc.**

**426 Bouchelle Drive,  
New Smyrna Beach, FL 32169**

**Project Number: 2409333**

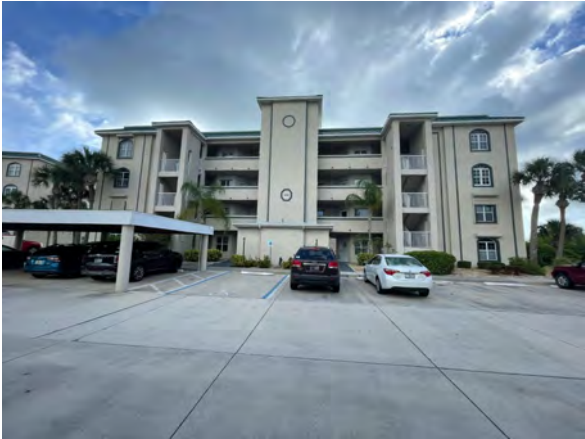
**PHOTO 1**

GENERAL VIEW OF PROPERTY

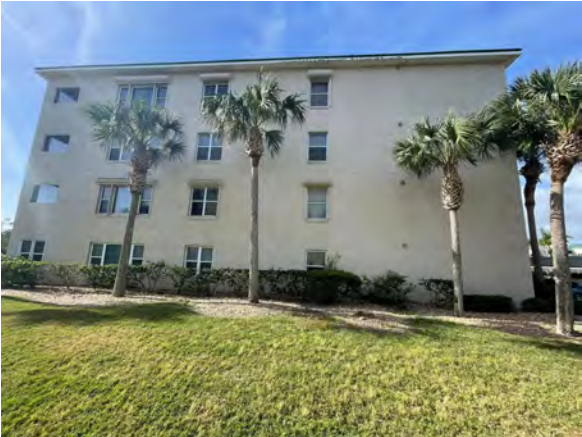
**PHOTO 2**

GENERAL VIEW OF PROPERTY

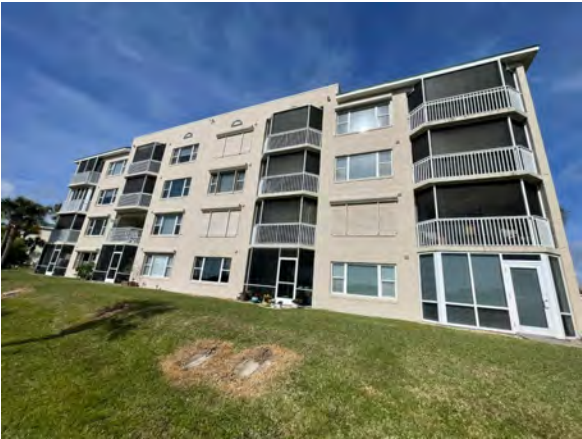
**PHOTO 3**

GENERAL VIEW OF PROPERTY

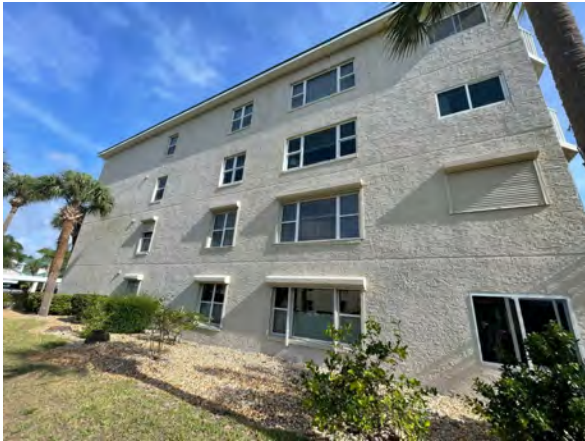
**PHOTO 4**

GENERAL VIEW OF PROPERTY

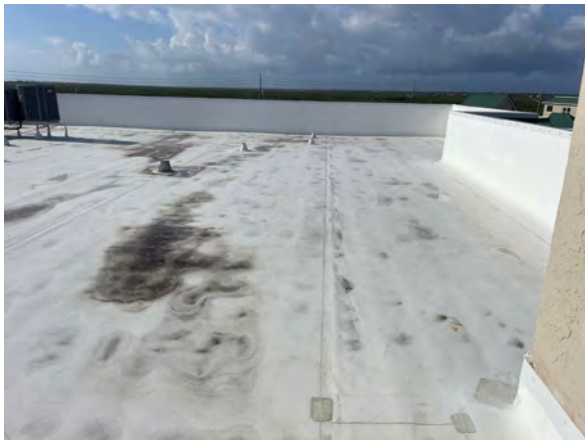
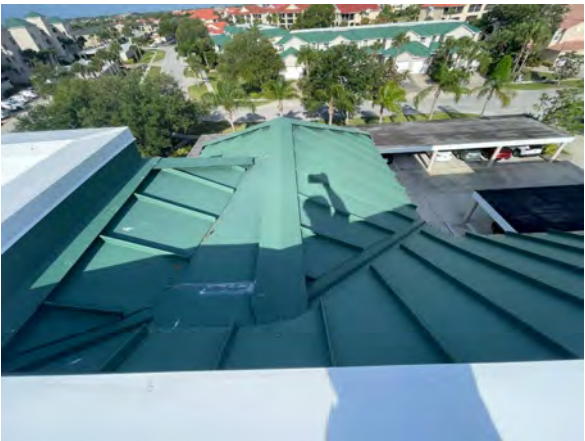
The roof is a mixture of sloped wood mansards, covered with plywood decking and standing seam metal, along with a flat roof supported by a wood truss system, covered with plywood decking and thermoplastic polyolefin (TPO). Per the buildings representative the roof was reported to be replaced in 2023. The roof was observed to be in good condition with no significant deficiencies noted. No roof replacement is anticipated during the evaluation period. However, funds have been spread throughout the Reserves Table to ensure the availability of funds at the end of the element's EUL.

GENERAL VIEW OF TYPICAL ROOFTOP

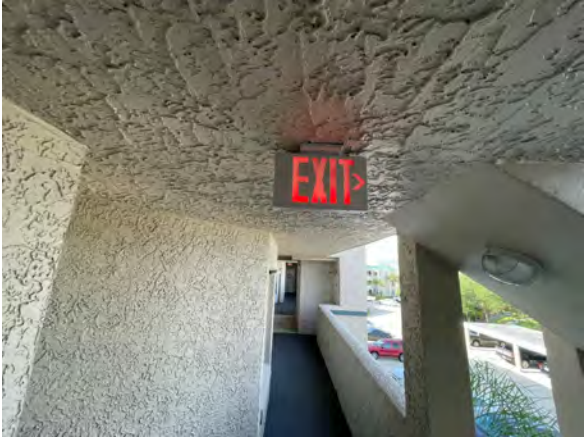
PHOTO 7

GENERAL VIEW OF EXIT LIGHTS

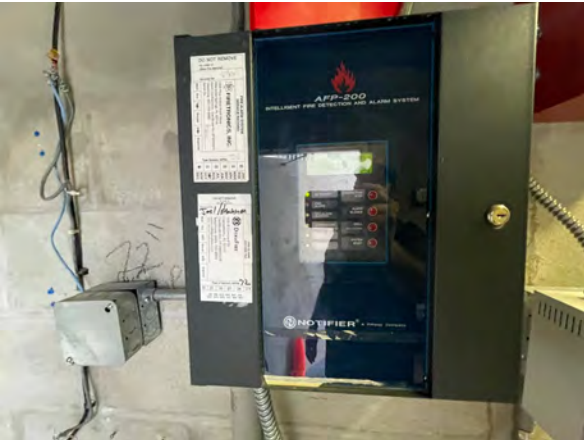
PHOTO 8

Item	Description/Observations/Comments
<b>Fire Protection</b>	<p data-bbox="597 312 1455 390">Portable fire extinguishers, pull stations, and fire alarms are in common areas. There are fire sprinklers located inside the individual units.</p> <p data-bbox="597 428 1455 506">The Property's fire alarm systems utilize central panels for monitoring manual pull stations in the three-story buildings.</p> <p data-bbox="597 543 1455 621"><b>The fire extinguishers were noted to be in general condition requiring routine maintenance over the evaluation period.</b></p> <p data-bbox="597 659 1455 926">The central alarm panels are in good condition. Central fire alarm panels typically have an EUL of 25 years. Funds have been spread throughout the Replacement Reserves Cost Estimate Table, adopting the straight-line accounting method to ensure the availability of funds at the end of the replaced element's EUL, beyond the evaluation period of this assessment.</p> <p data-bbox="597 963 1455 1094">Fire protection and life safety systems within the dwelling units are reported to be the responsibility of the respective condominium unit owner to maintain and replace.</p>

GENERAL VIEW OF FIRE ALARM PANEL

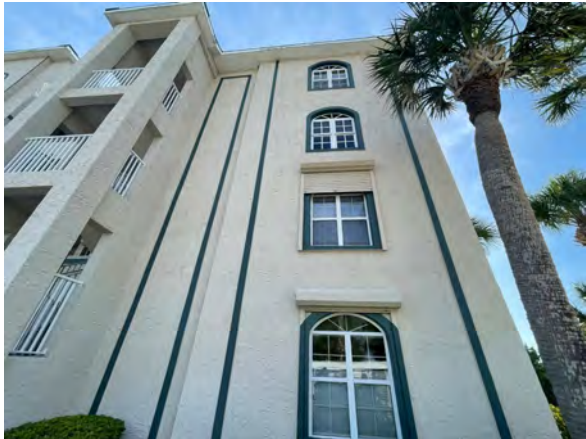
**PHOTO 10**

GENERAL VIEW OF BUILDING EXTERIOR FINISHES

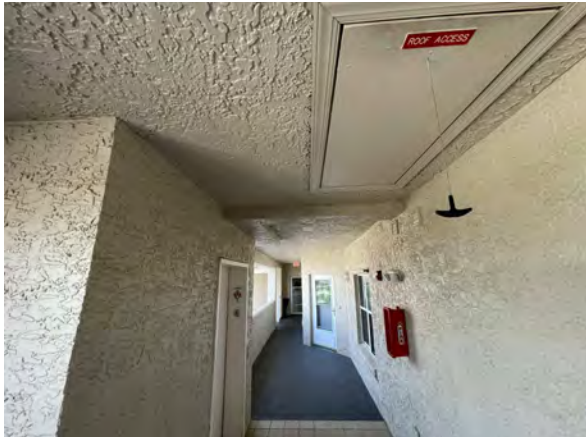
**PHOTO 11**

GENERAL VIEW OF BUILDING EXTERIOR FINISHES

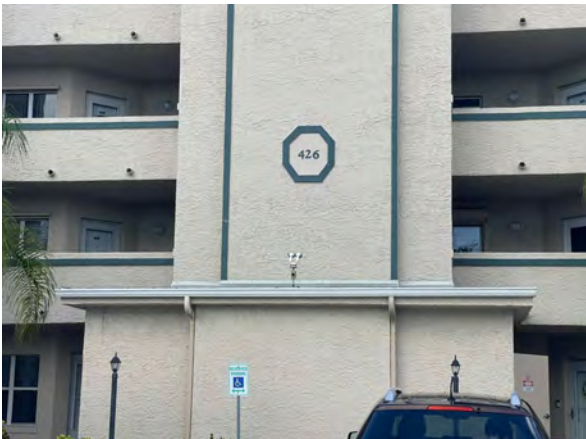
**PHOTO 12**

VIEW OF BUILDING EXTERIOR FINISHES

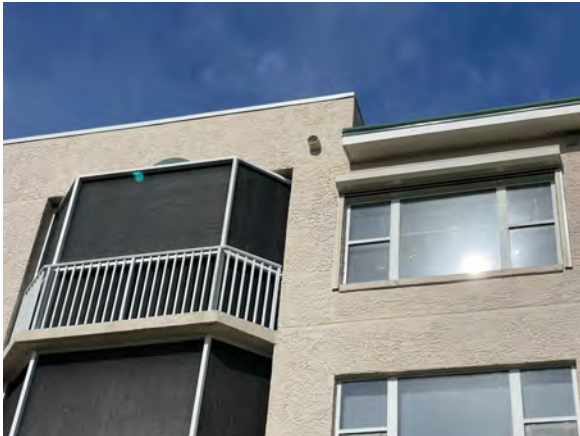
**PHOTO 13**

Item	Description/Observations/Comments
<b>Balconies</b>	<p>The balconies are concrete and supported by the structural systems of the building.</p> <p>Observed to be in good condition.</p>
<b>Exterior Walkways</b>	<p>The exterior walkways are concrete and supported by the structural systems of the building.</p> <p>Observed to be in good condition.</p>
<b>Windows</b>	<p>The windows consist of a mix of aluminum (original) and hurricane rated (new) units.</p> <p><b>The windows appeared to be in generally good condition with no significant deficiencies noted, requiring only routine maintenance over the evaluation period.</b></p> <p><b>Windows at the condominiums are the responsibility of the respective unit owners to maintain and replace.</b></p>
<b>Doors</b>	<p>The exterior building entry doors are typically constructed of metal doors set in metal framing.</p> <p><b>The doors appeared to be in generally good condition with no significant deficiencies noted, requiring only routine maintenance over the evaluation period.</b></p> <p><b>Doors at the condominiums are the responsibility of the respective unit owners to maintain and replace.</b></p>

VIEW OF TYPICAL BALCONY

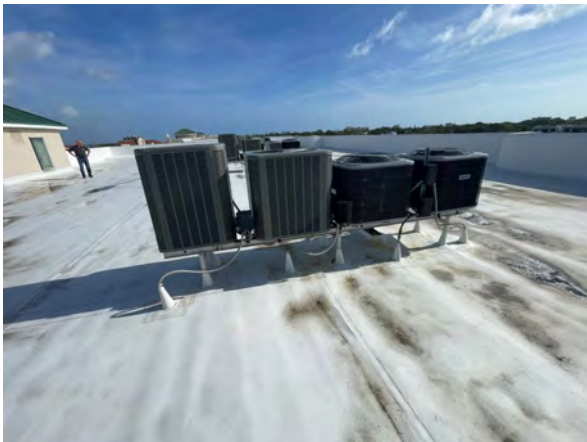
**PHOTO 14**

Item	Description/Observations/Comments
<b>HVAC</b>	<p>A/C condensing units are located near grade, mounted on a concrete pad. No issues were observed or noted.</p> <p><b>HVAC handling units and A/C condensers were reported to be the responsibility of the condominium owners to maintain and replace.</b></p>
<b>Plumbing Systems</b>	<p>The plumbing systems include the incoming water service and piping system; the sanitary sewer including the soil, waste, and vent system.</p> <p>“As-built” plans of the Property were unavailable for review to determine the below ground components; thus, we were unable to physically identify all types of piping used throughout the Property. According to available information and observations, supply piping appears to be copper, and waste and vent piping are considered to be PVC.</p> <p><b>The plumbing systems appeared to be in good condition. The water pressure, quantity of hot and cold water, and drainage were reported to be adequate. No abnormal plumbing problems were reported by the Property representative. With proper maintenance, no significant expenditures are anticipated. We have allocated some funds in the Reserve Table.</b></p> <p><b>Plumbing components and piping have EULs between 15 and 50 years. As such, an annual budget for component upgrades and replacements is recommended during the evaluation period. Funds have been spread throughout the Replacement Reserves Cost Estimate Table, adopting the straight-line accounting method to ensure the availability of funds at the end of the replaced element’s EUL, beyond the evaluation period of this assessment.</b></p>

VIEW OF HVAC EQUIPMENT

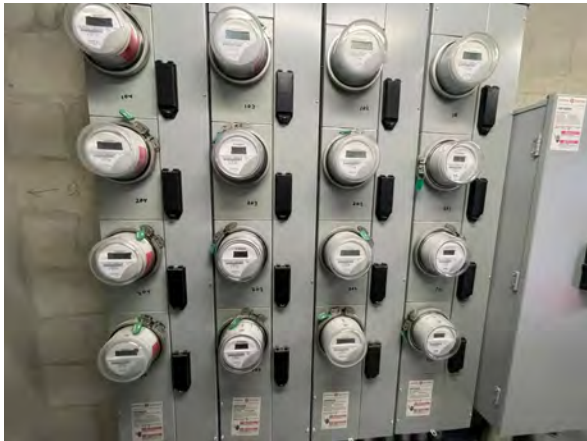
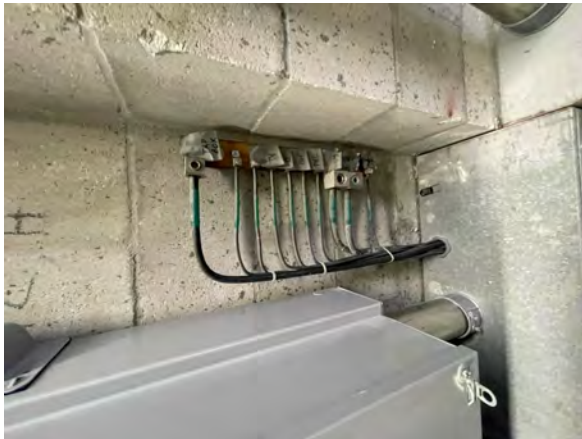
**The electrical system components were observed to be in good condition. In general, the electrical systems for the Property, including main switchboards, transformers, distribution circuit breaker panels, contactors, lighting, and wiring system were noted to be adequately sized for the intended use of the facility. With proper maintenance, no significant expenditures are anticipated. We have allocated some funds in the Reserve Table.**

VIEW OF ELECTRICAL EQUIPMENT

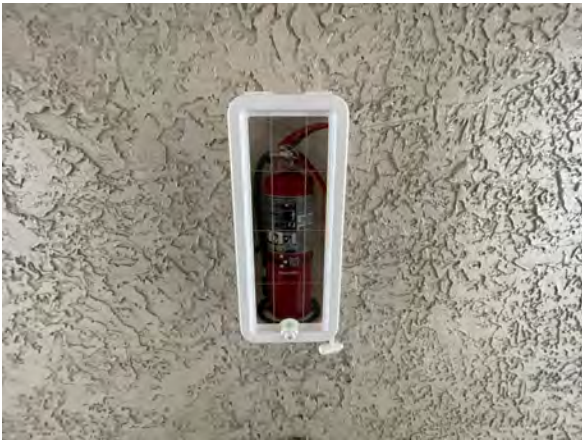
**PHOTO 18**

VIEW OF FIRE EXTINGUISHER

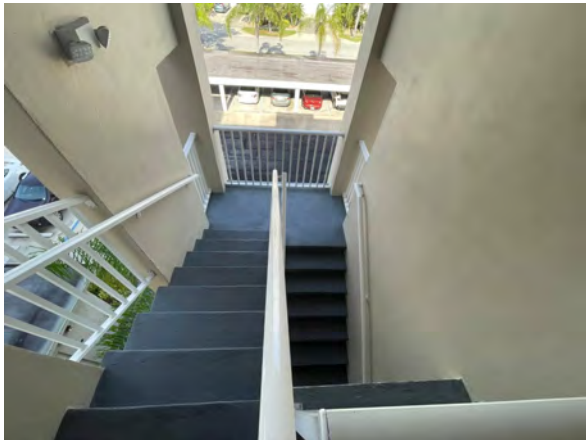
**PHOTO 19**

GENERAL VIEW OF STAIRWAY

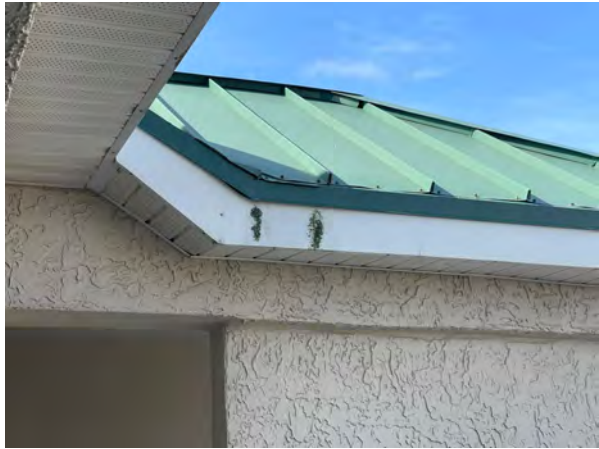
**PHOTO 20**

EXAMPLE OF SOFFIT

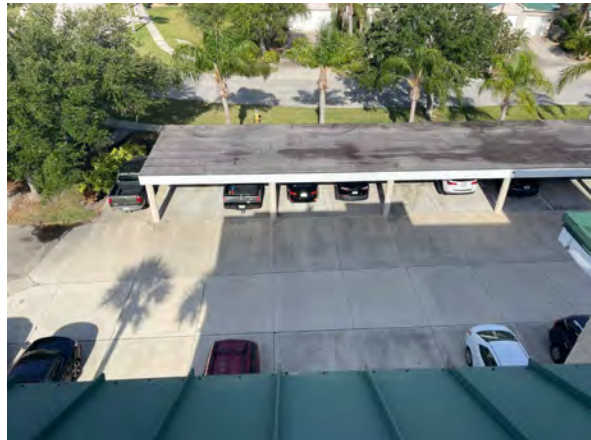
**PHOTO 21**

EXAMPLE OF PARKING
