444 Bouchelle Drive, New Smyrna Beach, Florida

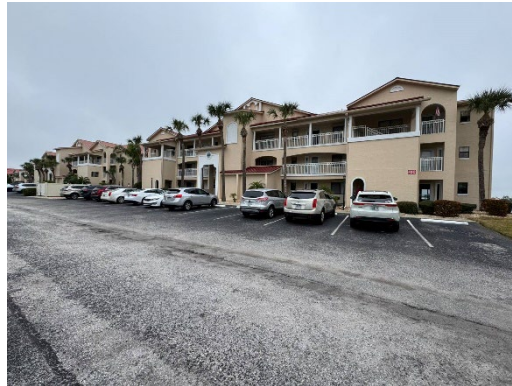
Photo 1

GENERAL VIEW OF PROPERTY

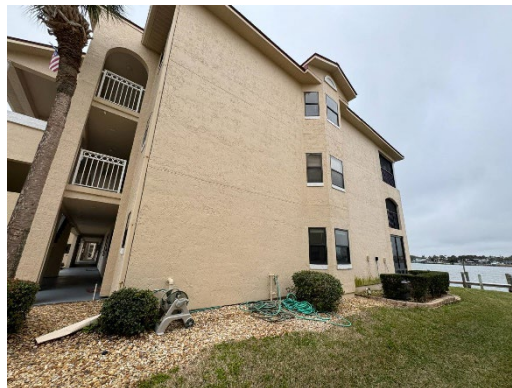
Photo 2

GENERAL VIEW OF PROPERTY

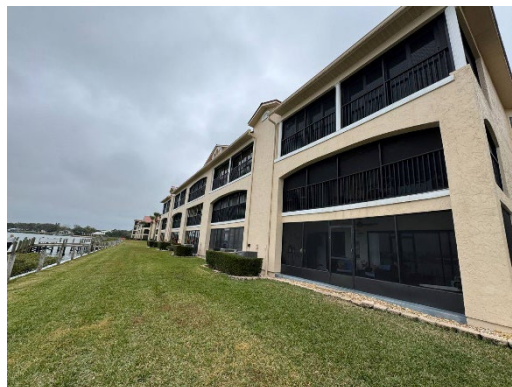
Photo 3

GENERAL VIEW OF PROPERTY

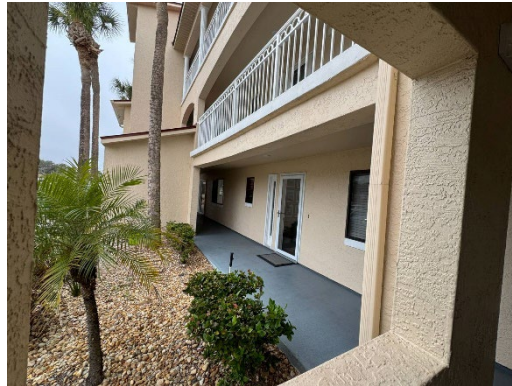
Photo 4

GENERAL VIEW OF PROPERTY

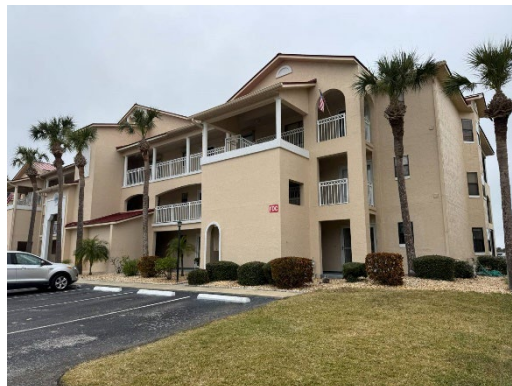
Photo 5

GENERAL VIEW OF PROPERTY

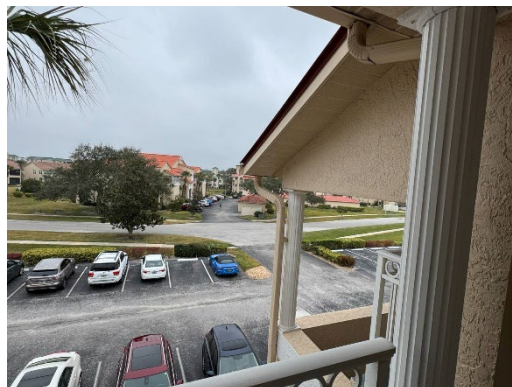
Photo 6

GENERAL VIEW OF PARKING

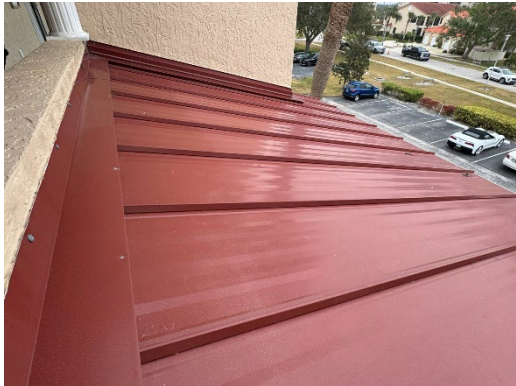
Photo 7

GENERAL VIEW OF TYPICAL ROOF

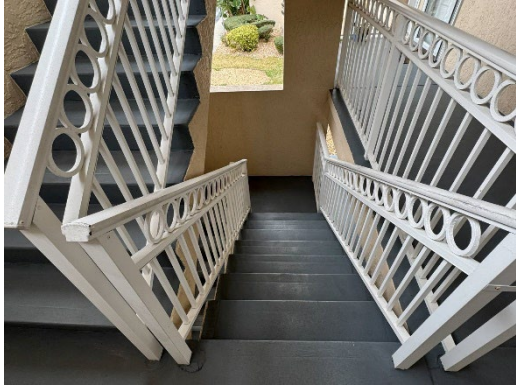
Photo 8

GENERAL VIEW OF TYPICAL STAIRWAY

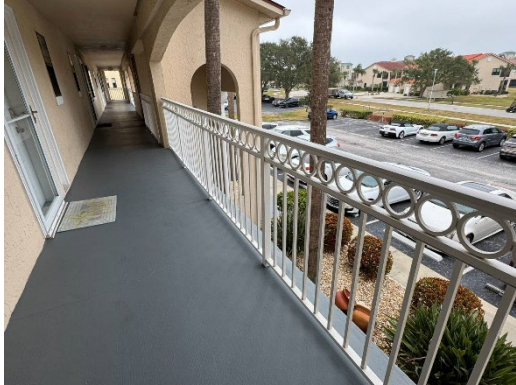
Photo 9

GENERAL VIEW OF TYPICAL ELEVATED WALKWAY

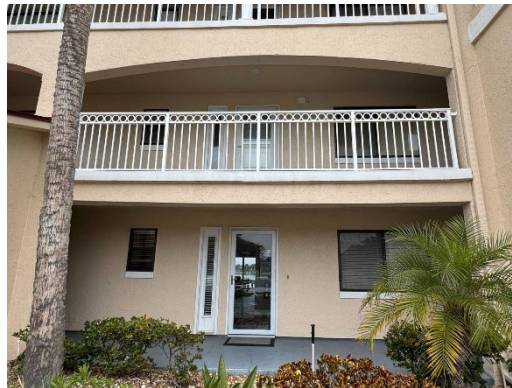
Photo 10

GENERAL VIEW OF GUARDRAILS

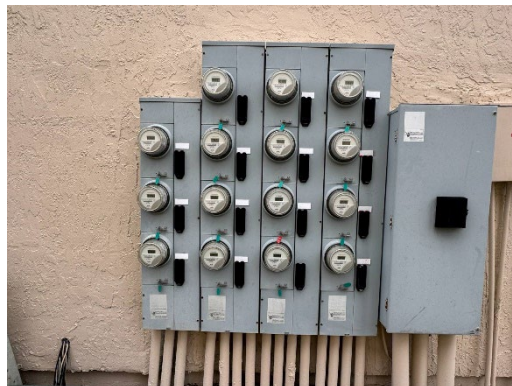
Photo 11

GENERAL VIEW OF ELECTRICAL EQUIPMENT

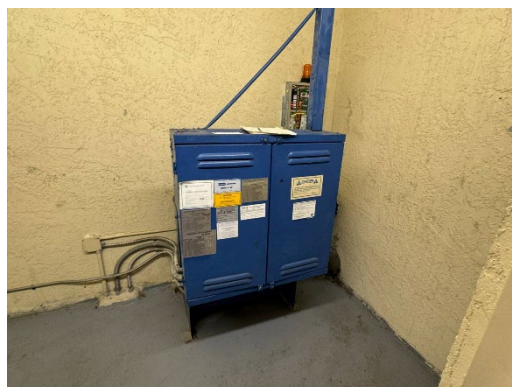
Photo 12

GENERAL VIEW OF ELEVATOR EQUIPMENT

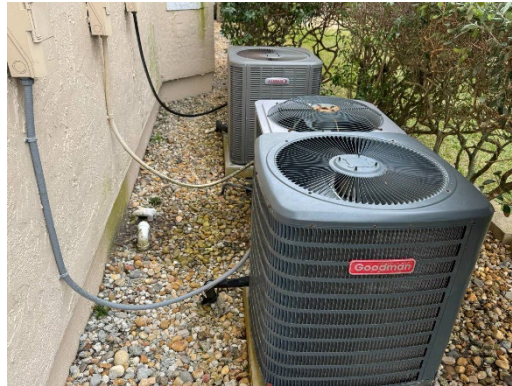
Photo 13

GENERAL VIEW OF HVAC EQUIPMENT

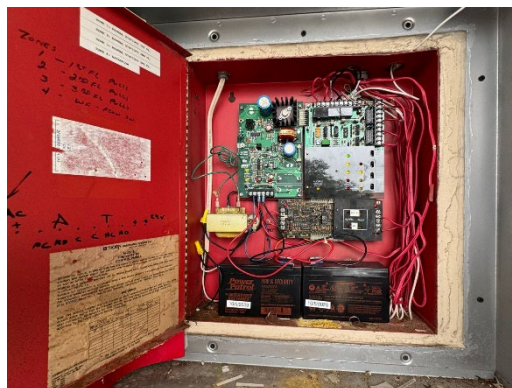
Photo 14

GENERAL VIEW OF FIRE ALARM PANEL

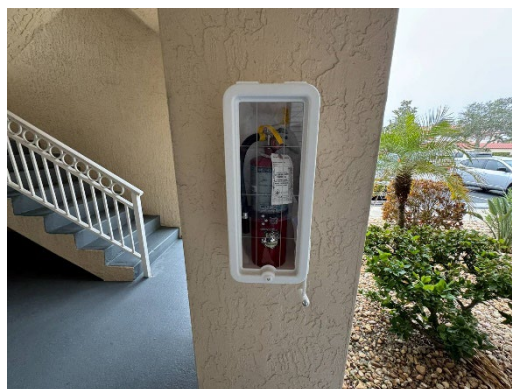
Photo 15

GENERAL VIEW OF FIRE EXTINGUISHER

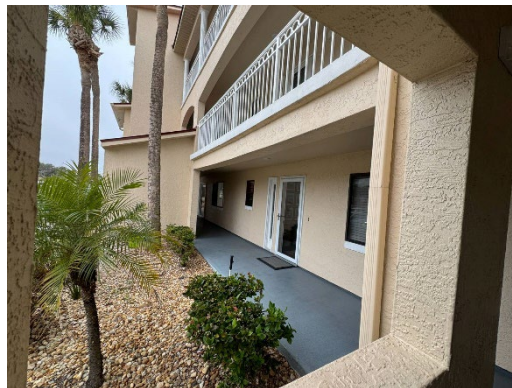
Photo 17

GENERAL VIEW OF BUILDING'S FINISH

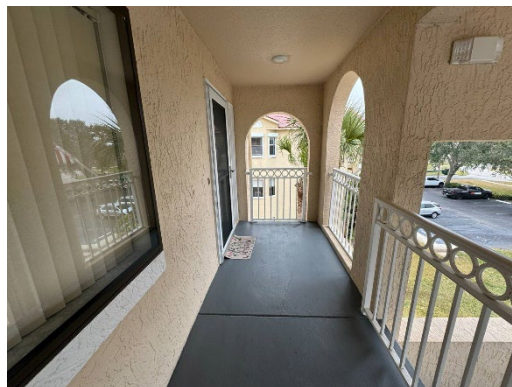
Photo 18

GENERAL VIEW OF BUILDING'S FINISH

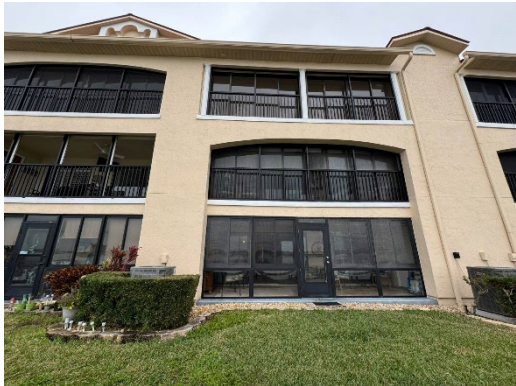
Photo 19

GENERAL VIEW OF BUILDING'S FINISH

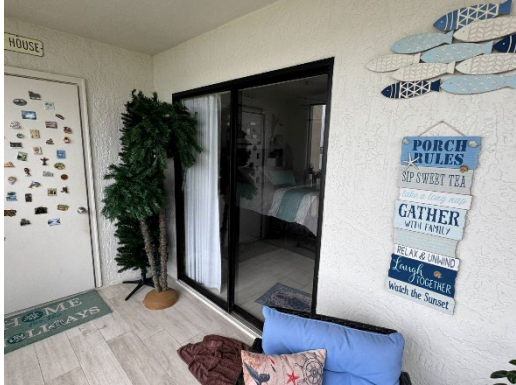
Photo 20

GENERAL VIEW OF BUILDING'S FINISH

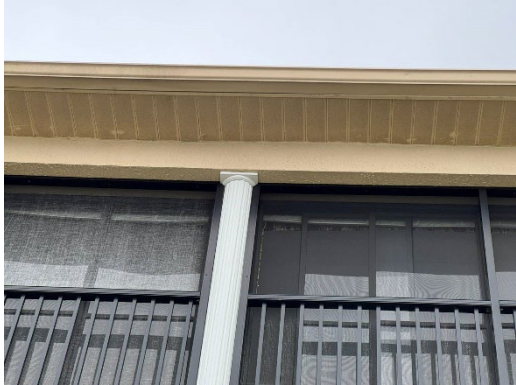
Photo 21

GENERAL VIEW OF BUILDING'S FINISH

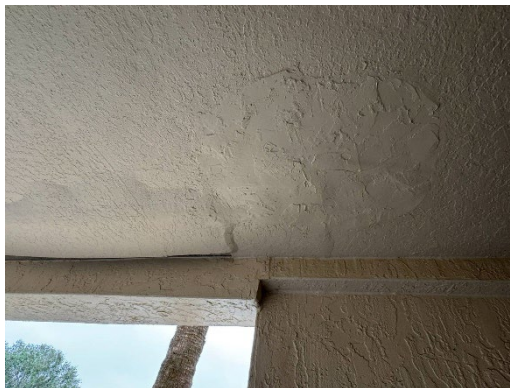
Photo 23

View of Bulging/Cracking in Stucco of previously repaired area on elevated walkway.

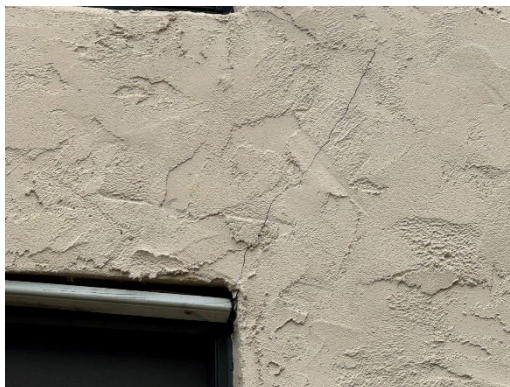
Photo 24

View of Stucco cracking at the edge of balcony.

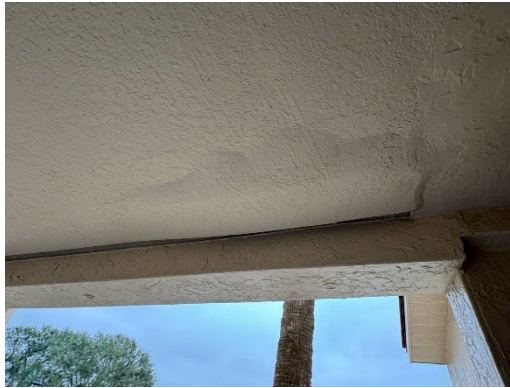
Photo 25

View of Bulging/Cracking in Stucco of previously repaired area on elevated walkway.

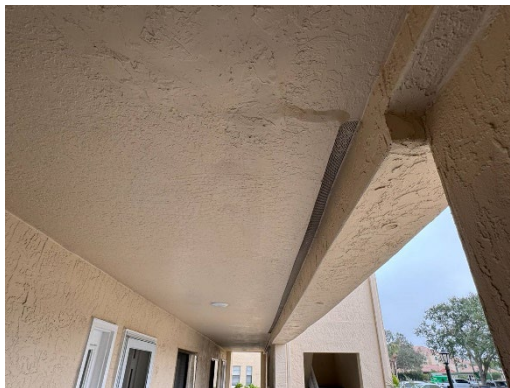
Photo 26

View of Bulging/Cracking in Stucco of previously repaired area on elevated walkway.

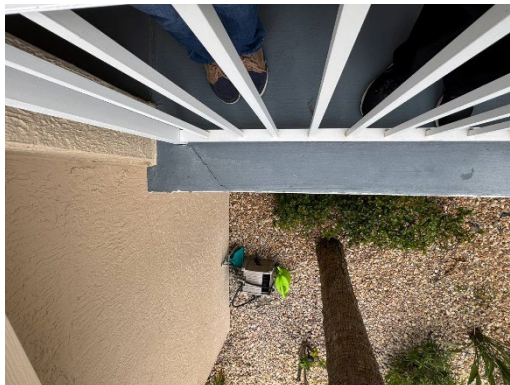
Photo 27

View of Cracking in concrete topping of elevated walkway.

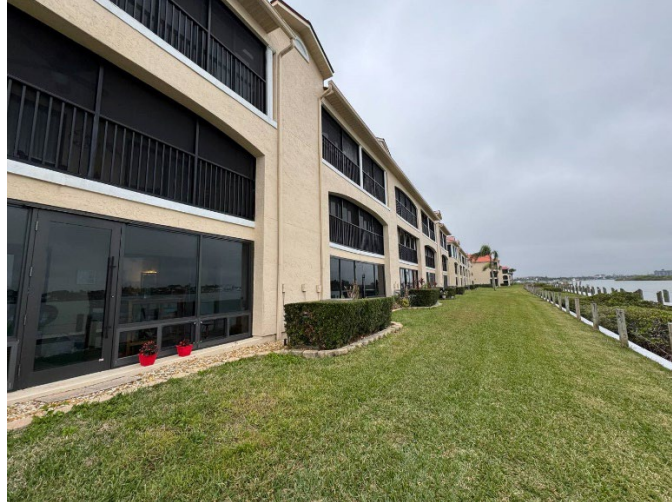
General view of deflections in wood beams supporting balconies at the rear of the structure.
