STRUCTURAL INTEGRITY RESERVE STUDY

**Bouchelle IV Condominium
Association, Inc.**

**444 Bouchelle Drive
New Smyrna Beach, Florida 32169**

February 28th, 2025

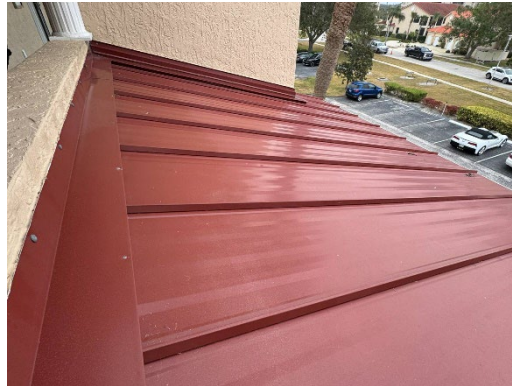
Photo 7

The sloped roof is supported by a wood truss system and is covered with standing seam metal panels. The roof coverings were reported to have been replaced in 2019 at a total cost of \$167,321. The roof coverings were observed to be in good condition with no significant deficiencies noted.

GENERAL VIEW OF TYPICAL ROOF

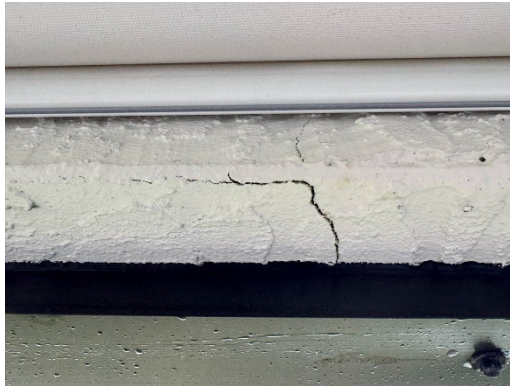
Photo 22

Item	Description/Observations/Comments
Balconies	The balconies are wood framed with concrete topping and supported by the structural systems of the building. Deflections along with cracking stucco were observed in multiple locations on the wood beams supporting the balconies. The balconies are scheduled to be repaired as part of the Phase II Milestone Inspection and will be addressed in 2025. As such, funds will be allocated in the Immediate Repair Table. Funds have also been spread throughout the Reserves Table for the continued maintenance of the balconies.
Exterior Walkway	The exterior walkways are wood framed and supported by the structural systems of the building. Bulging and deflections along with cracking stucco were observed on the elevated walkway at the front of the structure. The walkway is scheduled to be investigated/repared as part of the Phase II Milestone Inspection and will be addressed in 2025. As such, funds will be allocated in the Immediate Repair Table. Funds have also been spread throughout the Reserves Table for the continued maintenance of the walkway.

View of Stucco cracking at balcony beam.

Item No.	Sec.	Quantity	Unit	Cost	Totals	Existing Balance	Remaining Funds	Comments
1	Balcony investigation and repair	-	10	\$5,000.00	\$50,000	\$0.00	\$0.00	Remove deteriorated wood beams and Reinforce as required
2	Elevated Walkway investigation and repair		1	\$5,000.00	\$5,000	\$0.00	\$0.00	Remove and repair any deteriorated wood members
					Subtotal	\$0.00	(\$55,000.00)	
					Total Immediate Repairs			
					\$55,000			
					Cost Per Unit			
					\$3,666.67

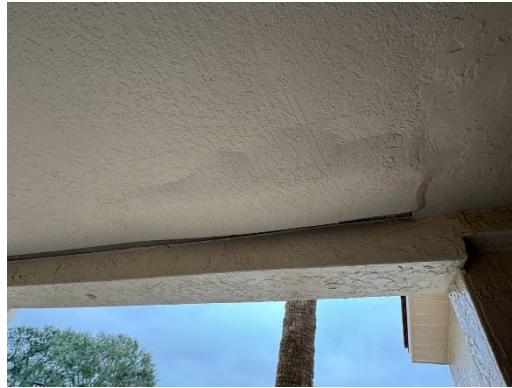
Photo 25

View of Bulging/Cracking in Stucco of previously repaired area on elevated walkway.

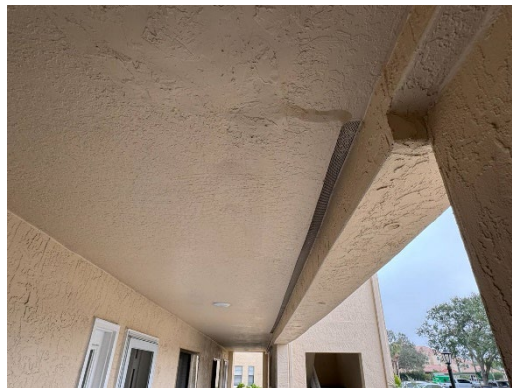
Photo 26

View of Bulging/Cracking in Stucco of previously repaired area on elevated walkway.

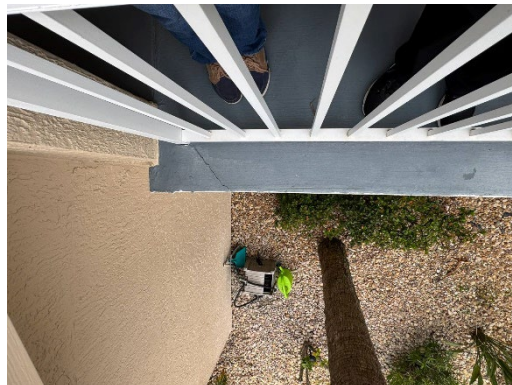
Photo 27

View of Cracking in concrete topping of elevated walkway.
