## **STRUCTURAL INTEGRITY RESERVE STUDY**

**Bouchelle Island XVII  
Condominium Association, Inc.**

**451 Bouchelle Drive,  
New Smyrna Beach, FL 32169**

**Project Number: 2409341**

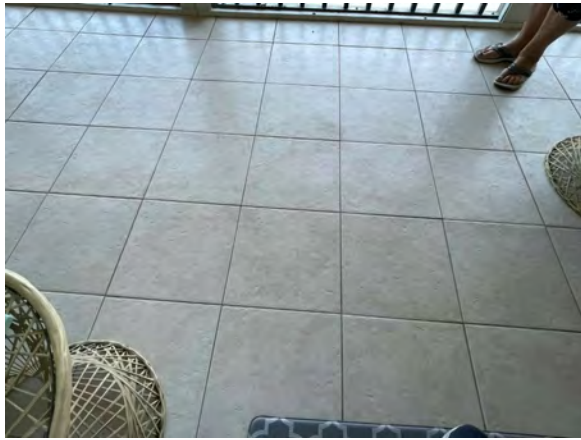
**PHOTO 14**

| Item | Description/Observations/Comments |
|---|---|
| <b>Balconies</b> | <p>The balconies are wood and supported by the structural systems of the building.</p> <p>Observed to be in FAIR condition.</p> |

VIEW OF BALCONY

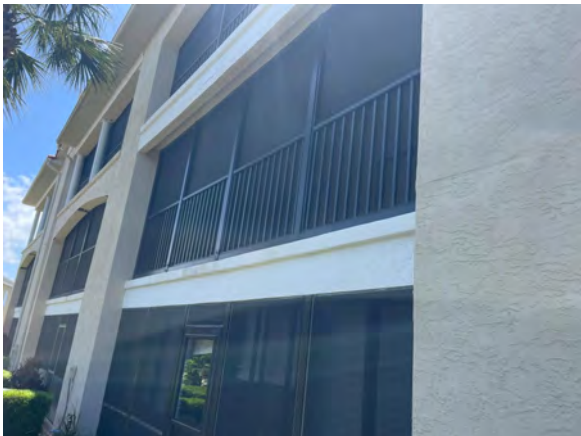
**PHOTO 15**

GENERAL VIEW OF BALCONIES AND REAR OF BUILDING

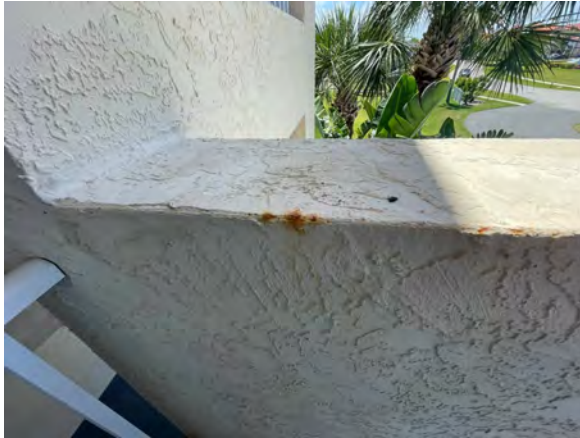
**PHOTO 19**

| Item | Description/Observations/Comments |
|---|---|
| Exterior Walls | <p>The exterior walls typically consist of CMU at stairs and wood frame construction main building, finished with painted stucco.</p> <p>The building was undergoing repainting and resealing. The left front side of the building was undergoing renovation at the time of inspection.</p> <p>The exterior walls appeared to be in good condition with minor scattered areas of stucco damage noted, requiring repair. Funds have been allocated in the Reserve Table.</p> <p>The exterior façades were reportedly repainted and waterproofed as part of regular maintenance in 2024. Based on the EUL of eight years, periodic repainting and waterproofing of the exterior wall surfaces, including any required repairs, should be anticipated during the evaluation period. Funds have been spread throughout the Replacement Reserves Cost Estimate Table, adopting the straight-line accounting method to ensure the availability of funds at the end of the replaced element's Expected useful Life (EUL), beyond the evaluation period of this assessment.</p> |

VIEW OF STUCCO CORNER BEAD DETERIORATION

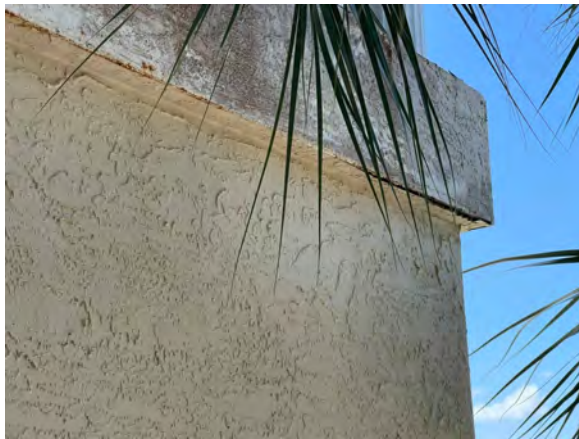
**PHOTO 20**

VIEW OF STUCCO CORNER BEAD DETERIORATION

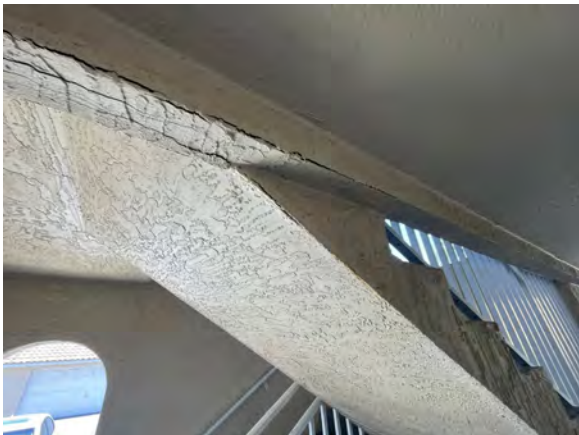
**PHOTO 21**

VIEW OF STUCCO CRACKING

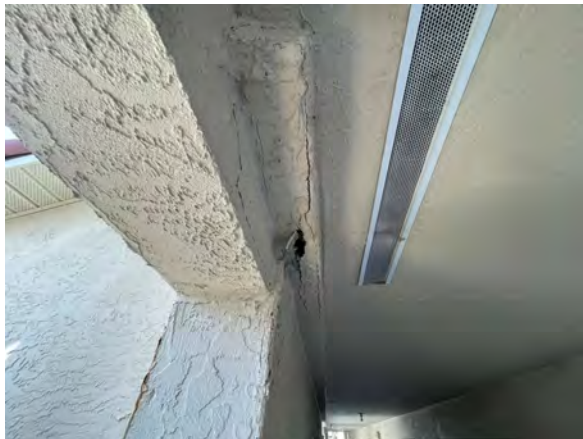
**PHOTO 22**

VIEW OF STUCCO CRACKING AND WATER INTRUSION

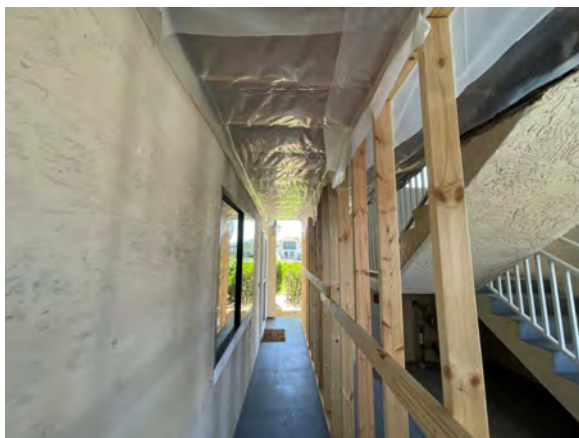
**PHOTO 23**

REPAIRS IN PROGRESS

| Item No. | e | Item Description | Quantity | Unit | Cost | Totals | Existing Balance | Remaining Funds | Comments |
|---|---|---|---|---|---|---|---|---|---|
| 1 | | None | 1 | LT | \$0 | \$0 | | | Current Repainting/Repair is undergoing in 2024 and already budgeted. |

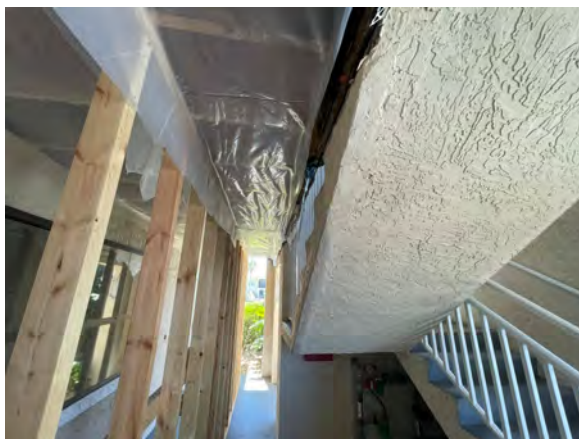
**PHOTO 24**

REPAIRS IN PROGRESS

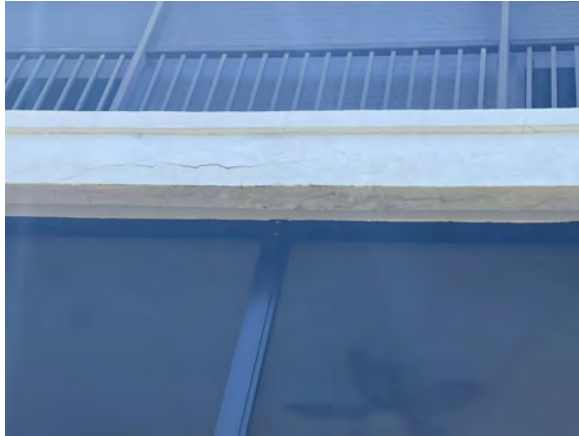
**PHOTO 25**

VIEW OF CRACKING STUCCO

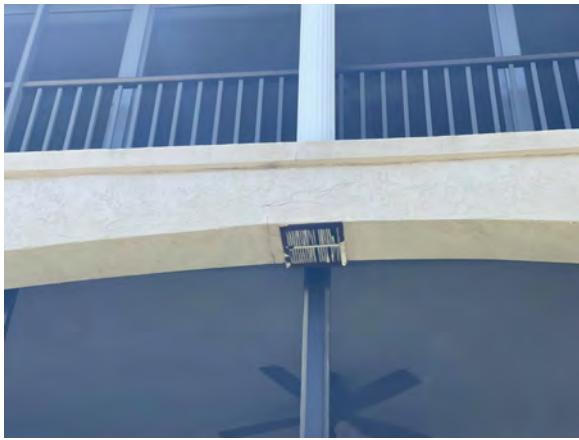
**PHOTO 26**

VIEW OF CRACKING STUCCO

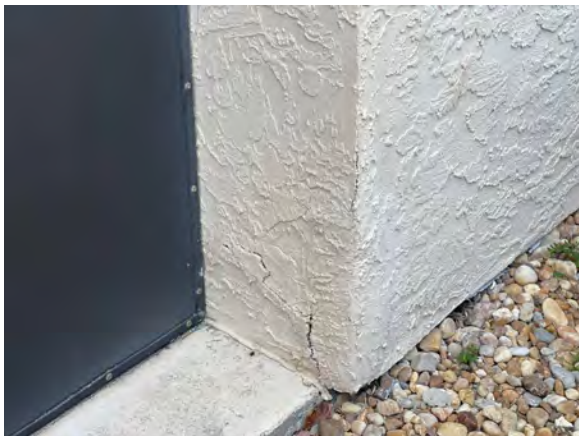
**PHOTO 27**

VIEW OF CRACKING STUCCO
