## STRUCTURAL INTEGRITY RESERVE STUDY

**Court of Palms on the Beach, LLC.**

**2780 & 2790 Ocean Shore Blvd.  
Ormond Beach, Florida 32176**

**Project Number: 2435240**

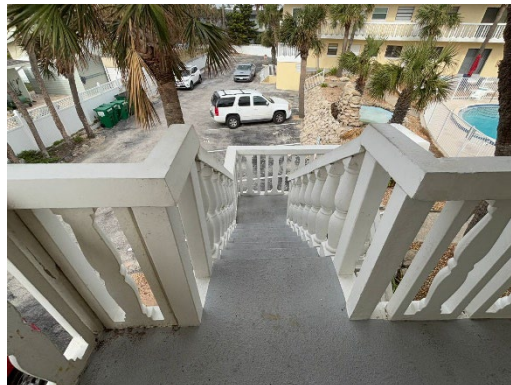
Photo 10

View of Typical Staircase

| Item | Description/Observations/Comments |
|---|---|
| Stairs | <p>There are two sets of exterior staircases per building that are concrete with concrete and aluminum handrails.</p> <p><b>The stairs appeared to be in good condition with some repairs planned during their current restoration project.</b></p> <p><b>In addition, periodic repainting and waterproofing of the stairs, including any anticipated repairs, are addressed as part of the Structural recommendations discussed above.</b></p> |

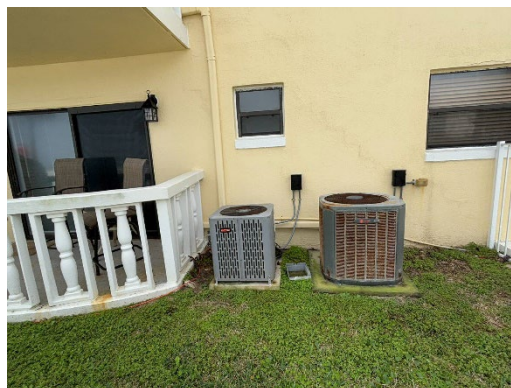
Photo 15

View of HVAC Equipment

| Item | Description/Observations/Comments |
|---|---|
| 2429938HVAC | <p>The A/C condensing units are located around the building on grade.</p> <p>The A/C equipment was observed to be in good condition with no significant deficiencies noted.</p> <p><b>HVAC handling units and A/C condensers were reported to be the responsibility of the condominium owners to maintain and replace.</b></p> |

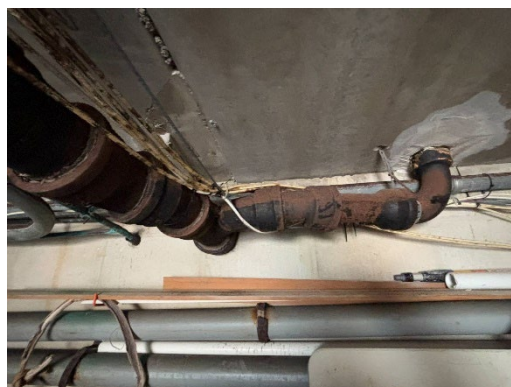
Photo 16

View of Drain Line

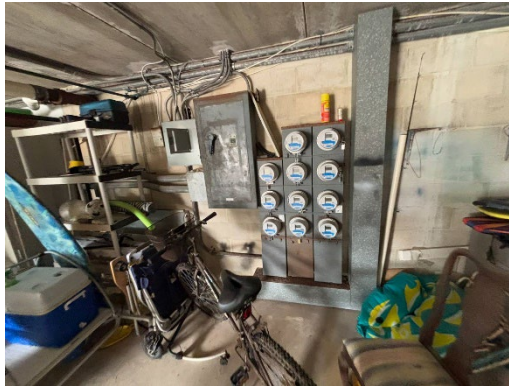
Photo 17

View of Electrical Equipment

Electrical service enters the building from utility-company owned transformers, providing 100-Amps (minimum), 120/240-Volt, single-phase, three-wire service to the individual units. The distribution wiring was noted to be copper.

**The electrical system components were observed to be in good condition. In general, the electrical systems for the Property, including main switchboards, transformers, distribution circuit breaker panels, contactors, lighting, and wiring system were noted to be adequately sized for the intended use of the facility. With proper maintenance, no significant expenditure is anticipated. We have allocated some funds in the Reserve Table.**

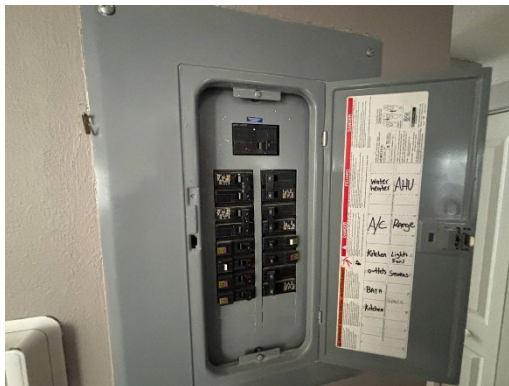
Photo 18

View of Electrical Equipment

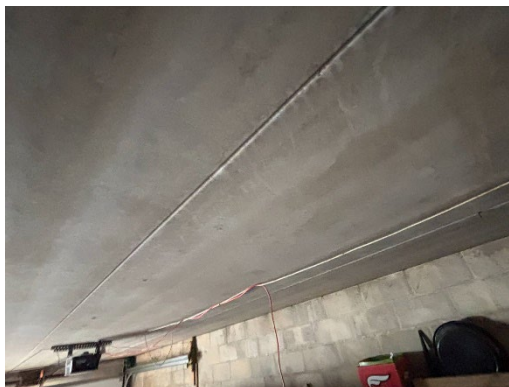
Photo 19

General View of Concrete Slabs and CMU Walls
